# The Decommissioning of DRES Building 12

July 1997

# **SUFFIELD REPORT No. 655**

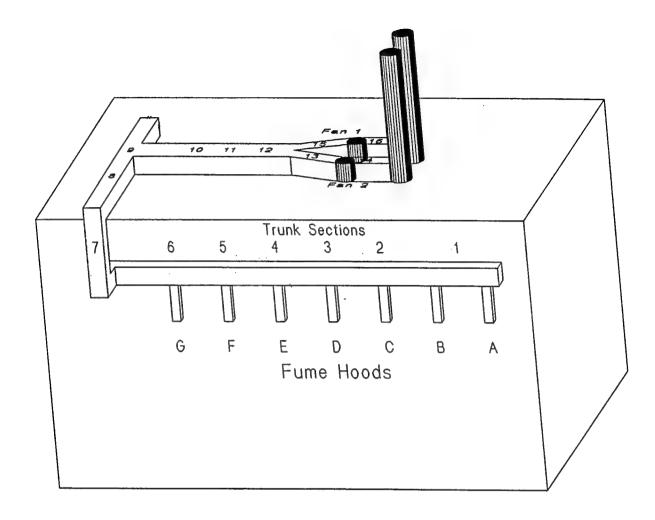
Figure 9. Schematic Of R/A Laboratory Fume Hood Trunking

Radiological contamination was detected inside the fume hood trunking leading from the fume hoods along the south side of the R/A Laboratory in the agent simulant preparation area [7]. The highest levels (up to 15 Bq/cm²) were detected in the trunking near fume hood A (see Figure 9) with the level decreasing as the distance from fume hood A increased. No contamination was found on the vertical section of trunking leading from the fan mounted on the roof of Building 12, nor on the roof itself. In total, 18 m of trunking (surface area =  $41 \text{ m}^2$ ) between fume hood A and fan No. 1 was found to be contaminated. The total activity calculated for the contaminated trunking is given [7] in Table IV. The contamination was in the form of a thick layer of dust/dirt (up to 2 cm deep) inside the trunking. Sample analysis in these and other contaminated areas (see below) indicated that Strontium-90 and its daughter product Yttrium-90 (Y<sup>90</sup>, t<sub>1/2</sub> = 64 h) were the source of the radiological contamination.

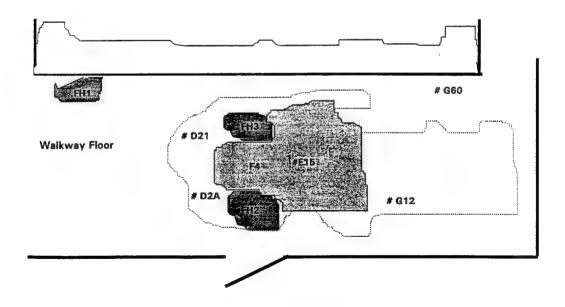
Figure 10. Distribution Of Contamination On R/A Laboratory Walkway

Approximately 10 m<sup>2</sup> of concrete walkway located adjacent to the exterior of the R/A Laboratory in the southernmost portion of Building 12 was found to be contaminated with Strontium-90. The distribution of the contamination was in the form of discrete "hot spots", as shown schematically in Figure 10. The level of contamination ranged from approximately 80 Bq to 1215 Bq, as measured with a Berthold Area Contamination Meter equipped with a beta/gamma tube [7].

A hole approximately 10 cm x 10 cm x 2 cm deep was chipped in the concrete at one of the strongest 'hot spots" to estimate the depth of contamination. Readings at the bottom of the hole were an order of magnitude less than the surface readings but were still at least one order of magnitude above background. These results and the contamination pattern indicated the contamination was likely caused by a spill of a Strontium-90 liquid source on the concrete which was subsequently spread along the walkway, probably by people walking through the area. The liquid had penetrated the concrete to a depth greater than 2 cm. The total amount of contamination, estimated by summing the activity in each area for the total number of areas, was approximately 300 kBq [7]. The average contamination level over the affected walkway area was 3 Bq/cm², yielding a dose rate 0.5 m above the contaminated walkway of approximately 1 μSv/h, which exceeded regulatory criteria.

The fixed contamination on the floor of the concrete walkway outside of the R/A Laboratory vault centred around three "hot spots", designated as FH1, FH2 and FH3 in the schematic drawing in Figure 10. The walkway was completely isolated in accordance with the contamination control plan. Plastic sheeting was placed over all doorways leading to this area and a "clean/dirty" line was established, as shown in Figure 12.

Starting with the "hot spots", the concrete was first chiselled to an average depth of 2 cm, followed by conducting a radiological survey. The survey results indicated that the contamination had penetrated the concrete to a greater depth. For example, contamination was detected at depths exceeding 10 cm in the FH2 area. This was attributed to the possibility that a liquid spill containing Strontium-90 had penetrated a crack which ran across the area, as shown in Figure 13. The concrete was further chiselled away and surveys repeated until the contamination levels were reduced to background levels.

The fine concrete dust produced while chiselling was carefully collected with small brushes into dust pans. Damp disposable cloths were then used to wipe the entire area in order to remove the fine dust trapped in the rough surface of the decontaminated areas. All contaminated concrete rubble, dust and cloths were packaged as contaminated waste for disposal.

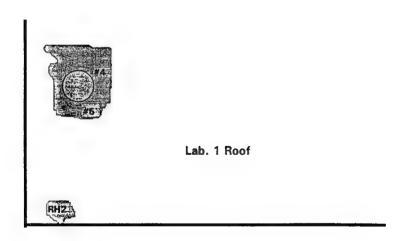
Figure 11. Distribution Of Contamination On R/A Laboratory Roof

Two separate contaminated areas, located underneath joints in the exterior fume hood trunking, were identified on the concrete roof of the R/A Laboratory vault, as shown schematically in Figure 11. The larger area encompassed approximately 1.8 m², while the smaller area covered approximately 0.12 m². Of 9 swipe samples taken in these areas, only one indicated the presence of loose contamination. This sample showed activity near the detection limit of the swipe counter and was well within regulatory limits for loose contamination.

The total activity for the larger contaminated area located under Trunk Section #9 was estimated [7] to be 2 kBq, with an average surface contamination of 0.06 Bq/cm<sup>2</sup>. At a distance of 0.5 m, the corresponding dose rate was well below regulatory limits, indicating that there was no requirement to perform remedial decontamination in this case. For the smaller area located under Trunk Section #7, the total activity was estimated to be 100 Bq with an average surface contamination of 0.04 Bq/cm<sup>2</sup>. The corresponding dose rate at 0.5 m was again within regulatory limits.

The concrete roof of the R/A Laboratory vault was decontaminated in the same manner as the walkway. As shown schematically in Figure 11, two separate areas located underneath the joints of the exterior fume hood trunking, designated RH1 and RH2, were identified for decontamination. As noted above, the fume hood trunking had been removed and decontaminated previously. Small dust containment huts were constructed and placed around the contaminated areas to completely isolate these areas. All decontamination work was then carried out inside these huts, as shown in Figure 14.

The work on area RH2 centred around a steel-lined access hatch located in the R/A Laboratory roof. Fixed contamination was detected between the liner and the concrete. This area was thoroughly decontaminated by carefully scrubbing with steel brushes and wiping the inside of the liner and the space between the liner and concrete, as shown in Figure 15. Fine dust trapped in the rough surface of decontaminated areas, around the steel liner and inside the containment huts was carefully collected using damp cloths. Decontamination work continued until the contamination levels were reduced to background levels.

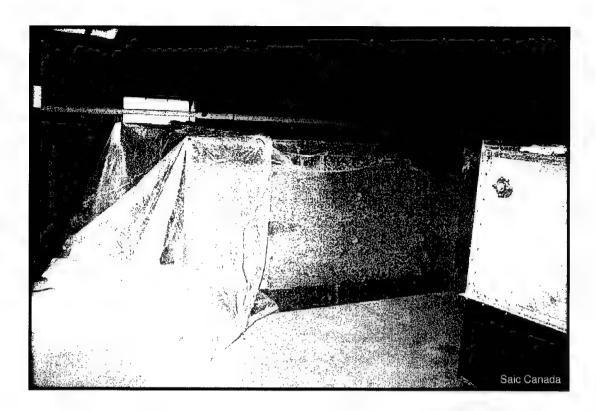
Figure 14. Contamination Control Using A Dust Containment Hut

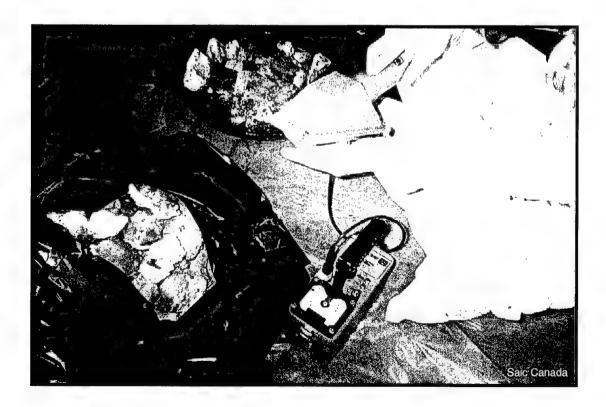
Figure 16. Radiological Survey of Removed Concrete

The solid waste accumulated during the decontamination work included contaminated concrete, cleaning tools and protective clothing. This waste, with a total volume of approximately 0.36 m³, was contained in two 205 L drums. All pieces of removed concrete were first surveyed, as shown in Figure 16. Contaminated pieces were placed in the two drums while "clean" pieces were released as normal waste for disposal. At the completion of work, one drum was filled to capacity while the second drum was 80% full. The total weight of the waste was: drum 1:- 375.4 kg, drum 2:- 301.7 kg.

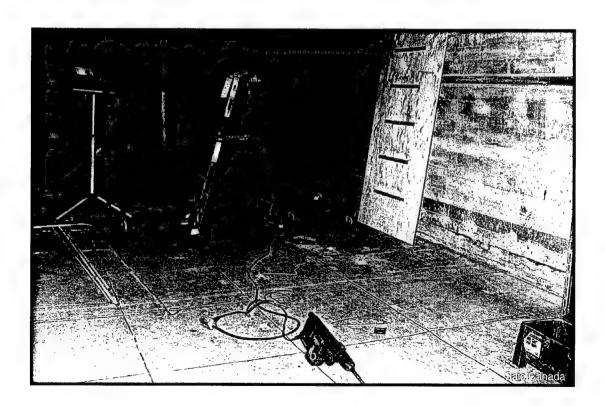
Figure 17. Cutting Lead Sheet With A Mechanical Chisel

The lead sheeting on the walls and floor of each vault were cut into 1 m x 1 m sections using a mechanical chisel, as shown in Figure 17. These smaller sheets were then rolled up (see Figure 18), removed manually from the vaults, unrolled and placed on wooden pallets as flat sheets. As shown in Figure 19, each pallet contained up to twenty sheets when fully loaded for transport. The lead sheets at the wall-mounting points were cut after removing the lead cap over the wooden strip to which the lead sheets had been press fitted, as shown in Figure 20. The ceiling sheets were cut flush to the joint between the wall and ceiling, as shown in Figure 21, leaving a small strip of lead underneath the concrete where the vault ceiling had been placed on top of the walls during construction. In the case of the vault with restricted access, a hole was cut out of the side of the vault at ground level to allow workers to enter the vault and remove lead sheet, as shown in Figure 22.

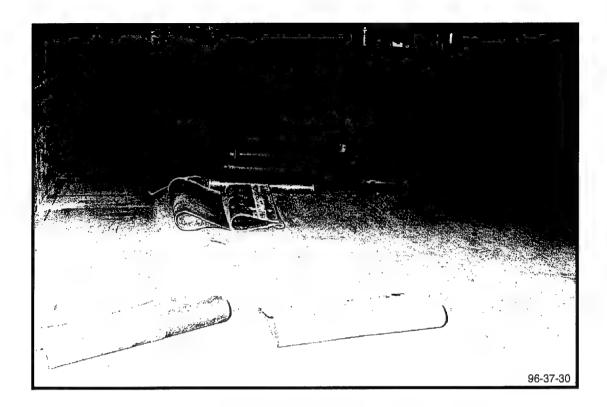
Figure 18. Rolled Up Lead Sheets

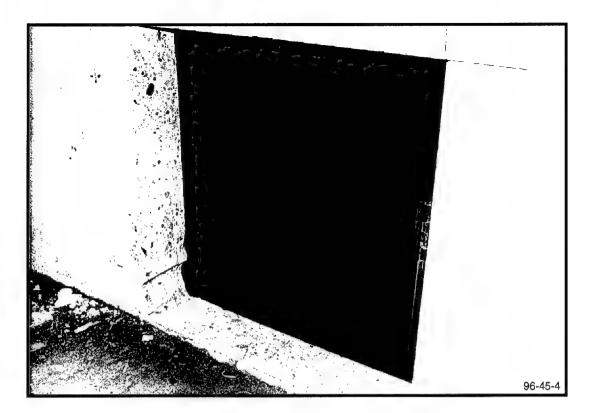
Figure 22. Access Hole To Central Vault
